Manhole Inspection Summary

Manhole # S31G__010MH

Insp Date: **10/27/08 3:02 PM**

Location Address: **149 baltimore st**

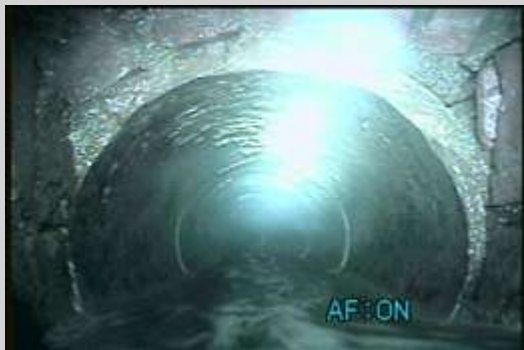
12 O'Clock Outflow

10 in. Circular Gravity Sewer
Pipe Out @ 12 O'Clock

Pipe Material: **Clay** ☐ Pipe Lined

Invert Depth: 17.41 (ft.) Flow Characteristics: **Fast**

Deposits: ☒ None ☐ Mud ☐ Sludge ☐ Debris ☐ Grease

Infiltration: **None** Pipe Seal Cond: **Unknown**

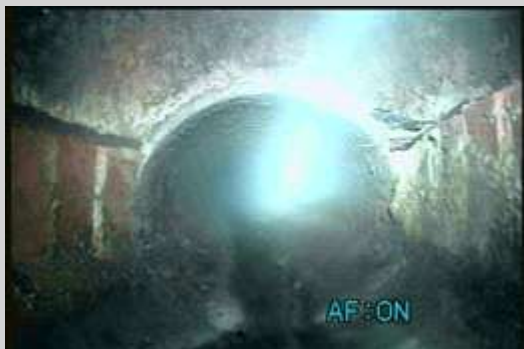
4 O'Clock Inflow

8 in. Circular Gravity Sewer
Pipe In @ 4 O'Clock

Pipe Material: **Clay** ☐ Pipe Lined

Invert Depth: 16.83 (ft.) Flow Characteristics: **Fast**

Deposits: ☒ None ☐ Mud ☐ Sludge ☐ Debris ☐ Grease

Infiltration: **None** Pipe Seal Cond: **Unknown**

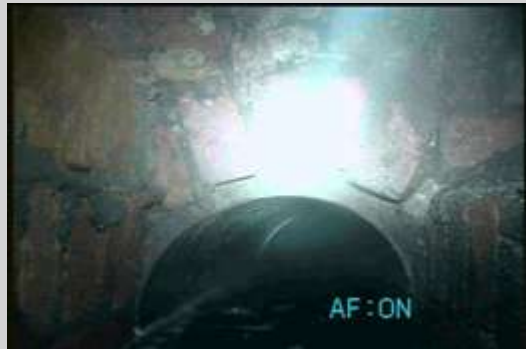
7 O'Clock Inflow

10 in. Circular Gravity Sewer

Pipe In @ 7 O'Clock

Pipe Material: **Clay** ☐ Pipe Lined

Infiltration: **None** Pipe Seal Cond: **Unknown**
